Technical Advisory

PGx303 PowerG Wireless Magnetic Door/Window Contact Magnet Alignment

Date: May 15, 2019

Product: PGx303 PowerG Wireless Magnetic Door/Window Contact

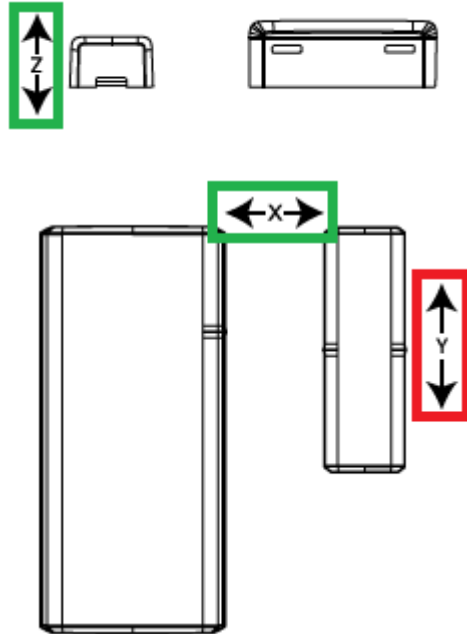
We have discovered a potential issue concerning the use of the PGx303 PowerG Wireless Magnetic Door/Window Contact. If this contact is installed in such a way that the magnet is pulled away from the reed switch along the long edge of the contact, this may result in up to a 20-second delay in communicating the violation to the panel, and if the magnet is restored prior to communication, it may result in the detector missing the violation. The issue is dependent upon how quickly the magnet is removed from the device. If the magnet is removed slowly, such as on a sliding door, it is more possible that the issue can occur.

In the interim, please ensure that the PGx303 PowerG Wireless Magnetic Door/Window Contact is installed so that the magnet moves away from the reed switch on either the X or Z axis, shown in the images below.

To minimize the potential occurrence of the issue, the PGx303 PowerG Wireless Magnetic Door/Window Contact must be installed vertically on a door that slides open horizontally, or horizontally on a window that slides open vertically.

Any PGx303 PowerG Wireless Magnetic Door/Window Contact installed with the magnet moving away from the reed switch on the 'Y' axis as in the photo above should be re-positioned so that the magnet moves away from the reed switch on the 'X' or 'Z' axis in the photo above.
