Number: NA TAB 03-001

Subject: PC5132-433 V4.20 (MASTER) WIRELESS KEY LOW BATTERY ISSUE

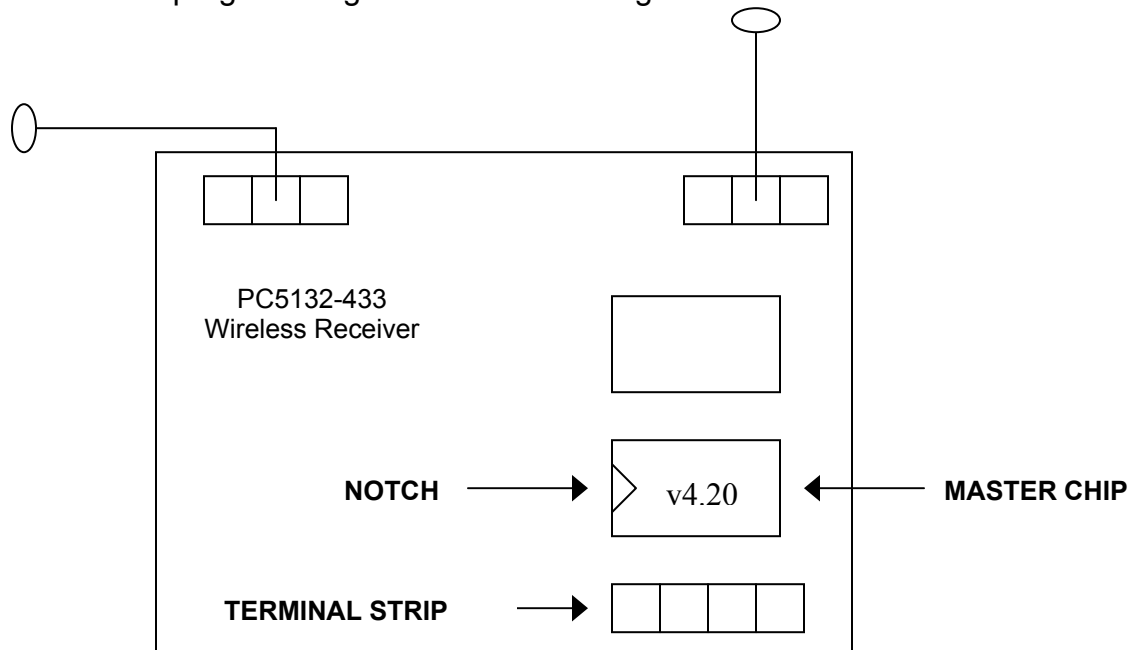
It is important to make sure the chip is orientated correctly. Refer to the diagram and make sure the notch on the chip is on the left side (see diagram).

1. Power down the control panel by removing the AC transformer and battery.
2. Remove the cover of the PC5132-433 receiver.
3. Using a screwdriver, carefully insert a flathead screwdriver underneath the Master Chip (see diagram) and carefully pry up to remove it.
4. Make sure the pins of the new chip are straight and carefully insert it into the socket.

5. Inspect the pins and make sure all the pins are in the socket correctly. If a pin is bent underneath, the receiver will not work properly.
6. Press down firmly on the top of the chip to make sure it is properly inserted.
7. Replace the PC5132-433 cover
8. Power up the control panel. There is no need to reprogram the PC5132-433 wireless receiver. All programming will remain unchanged.
