Number: TAB 05-006A

Skyroute Upgrade to v2.43 – Replacement for TAB 05-006

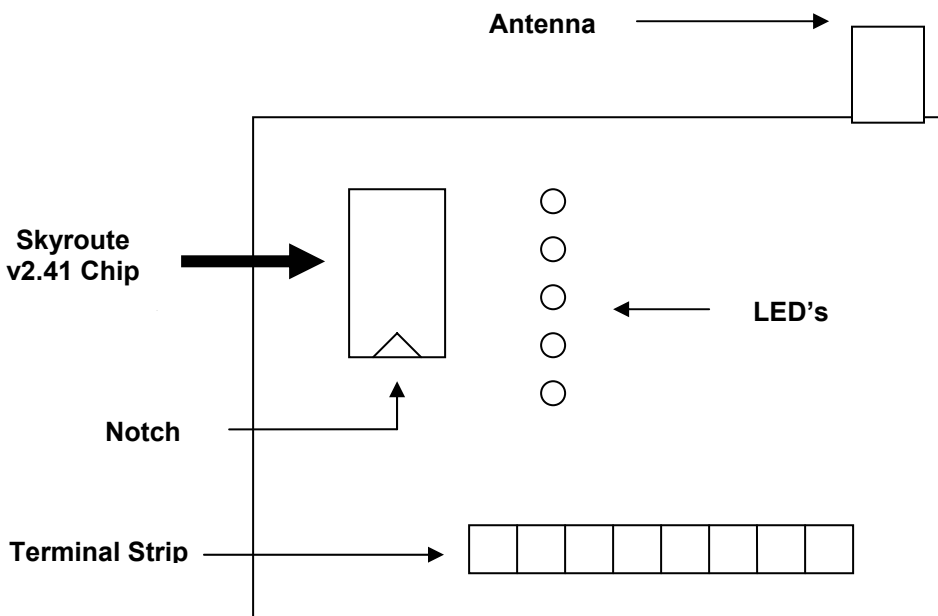
This is to inform you of an issue regarding the Skyroute Cellular Transmitter units manufactured after July 27, 2005. It is possible for the unit to retransmit previously transmitted alarm signals, resulting in erroneous information being sent to the Monitoring Center.

1. Power down the control panel by removing the AC transformer and battery.
2. Carefully insert a small, flathead screwdriver under the chip (see diagram) and carefully pry up to remove it.
3. Make sure the pins of the new chip are straight and carefully insert it into the socket.

It is important to make sure the chip is orientated correctly. Refer to the diagram and make sure the notch on the chip is on the bottom (see diagram).

4. Inspect the pins and make sure all the pins are in the socket correctly. If a pin is bent underneath, the unit will not perform properly.
5. Press down firmly on the top of the chip to make sure it is properly seated.
6. Power up the control panel. There is no need to reprogram the Skyroute. All programming will remain unchanged.
7. Test the system.
